# 2016 PSE Tier 1 and 2 Events

# Tier 1 and 2 OVERVIEW- GOM

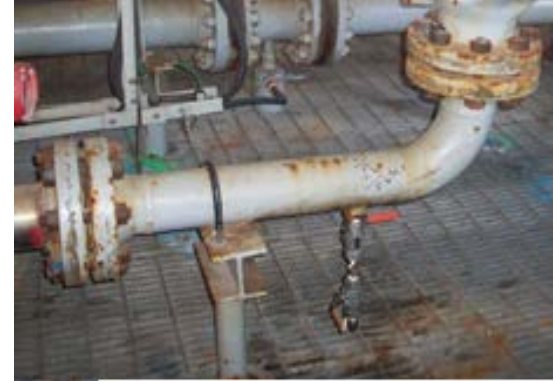
**Overview:** While making operator rounds, individuals noticed a gas smell and began troubleshooting. The source of gas was discovered to be a small packing leak on the Flow Control Valve (FCV) on a condensate line. In an attempt to isolate and change the packing, operations bled the line to atmosphere through a ½" low point drain and experienced a release of 350kg of natural gas.

- It was an acceptable practice to de-pressurize the 1026 psig line to atmosphere by manipulating the low point drain valve.
- Condensate was de-pressurized as a liquid by using the low point drain. It was viewed as normal conditions when only gas was coming out of the low point drain. This and other evidence indicate inconsistencies across operations on how condensate is viewed and handled (liquid vs. gas).
- The operators believed they could control the flow of natural gas through the ½" drain ball valve. The sudden slug of condensate caused them to lose control of the valve and barrier.

- Offshore leadership and operators interrupted execution of depressurizing the line differently. Offshore leadership assumed the operators would depressure to flare.
- The team bypassed the gas detection system before opening the drain valve to prevent a nuisance platform ESD. The team anticipated a potential gas cloud and thought to manage using manual mitigations rather than the automated system.
- The team concluded that changing the valve packing was a low risk job and could be performed under single isolation. This is acceptable under HSE0008 PR-06 Appendix 1 Mechanical Isolation Guide. However not acceptable using the UAD Hazard Factor Calculation spreadsheet.

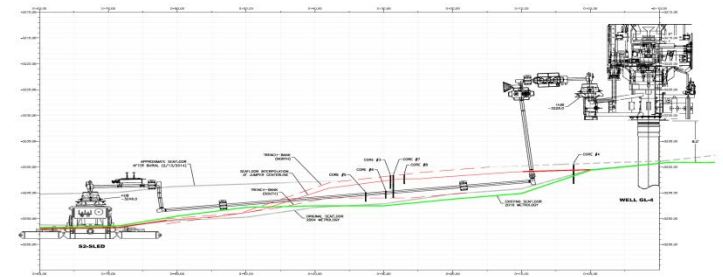
At approximately 7:55 am on Thursday, May 12th, a helicopter observed a sheen from the Glider subsea tieback system at Brutus. Shell estimates based on a monitored drop in pressure in the subsea infrastructure that 2100 barrels of oil were released. We are determining the cause of the release. There are no reports of injuries. Glider subsea field was shut-in from the platform. Spill response was initiated and a ROV was deployed to perform diagnostics to further understand the source of the leak.

- The investigation team looked at this event through two different work streams.
  - Failure of a load limiting joint on a jumper line at the Glider G4 well
    - The G4 jumper failed due to the moment load placed on the “belly” of the jumper in combination with typical forces (e.g. settlement, thermal expansion) placed on subsea kit. The forces on the jumper lined up in ways that were not foreseen in the modeling or risk discussions
  - Operations continued flowing the well for 7 hours
    - The leak happened during a ramp up from a xylene soak and aligned with moves that an operator had just made minutes prior to the leak starting
    - Since the feedback from the leak was very typical with the behavior of the system normally seen after xylene soaks, operations believed that the system was ok until the abnormal conditions had lasted normal than typically seen.

- Updated risk registers/risk models to add this scenario to our planning. Also added leak scenarios to the subsea training program to assist with leak recognition for subsea control operators
